Failure Analysis of a Low-Pressure Turbine Blade in a Coal-Based Thermal Power Plant

Abstract The failure of a turbine blade of a 60 MW thermal power plant is addressed in this paper. The findings of this study, based on the operating conditions and the characteristics of failed turbine blade, suggest a corrosion fatigue-related failure. The paper addresses the key elements that could have possibly lead to the failure of the turbine blade and highlights the importance of scrutinizing the operating conditions to eliminate the occurrence of such failures.

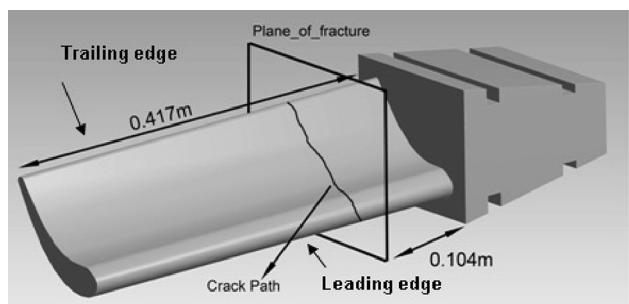
The failure happened as the blade breaking into two pieces with one piece attached to the rotor. A schematic of the failed turbine blade with the plane of fracture is shown in Fig. 1. As the first step of the analysis, the failed blade is visually examined. A photograph of the ripped off turbine blade piece in its as-received condition is shown in Fig. 2(a). The color of the surface of the blade was black. Of this figure, the highlighted (encircled) portion is shown in Fig. 2(b), i.e., the sample carved out of the failed blade for further analysis. From Fig. 2(b), it can be observed from the slightly perceivable beach marks on the fractured surface that the crack was initiated at the leading edge of the aerofoil region encircled in the figure. The other fractured surface (on the right side of encircled portion area) appears to be gradually detached portion due to fatigue prior to the ultimate failure with plastic deformation at the trailing edge. The corrosion deposits present on the fractured surface are shown in Fig. 2(c), and the region where the stereo micrograph is captured is indicated with an arrow in Fig. 2(b).

Fig. 1 Schematic diagram of the failed turbine blade indicating its fracture path

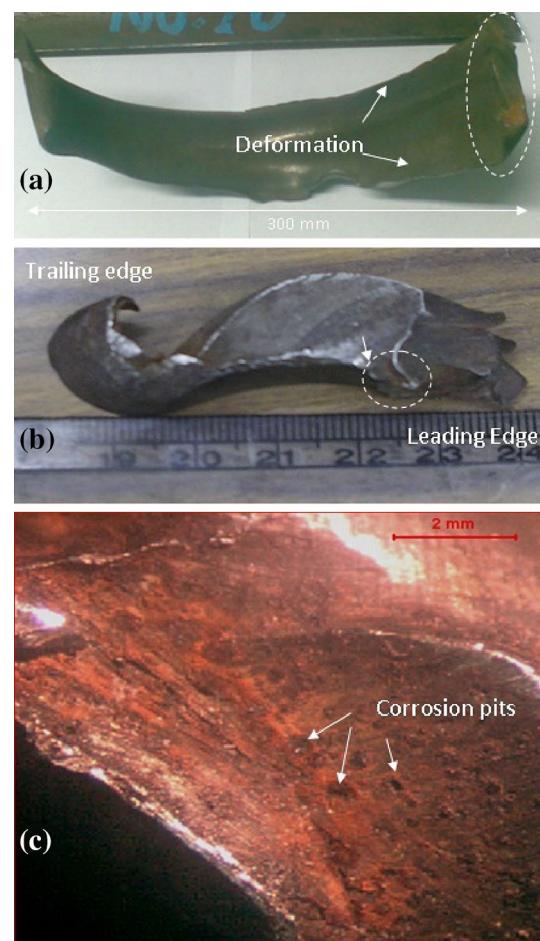
Fig. 2 Photographs of failed blade (a) in as-received condition (b) piece of blade used for analysis (highlighted in (a)), and (c) stereo micrograph taken along the along the fractured region edge (highlighted in (b))

severely affected by erosion. In case of LP steam turbines, it was reported that the leading edge of the blade is more prone to erosion by water drops in the wet steam [4]. Erosion is also possible by the impingement of silica carried by the steam [7]. The stereo micrograph images taken on the concave curvature of the blade at leading and trailing edges are shown in Fig. 4(c), (d) respectively. Several corrosion pits can be seen in these images. The micrograph shown in Fig. 4(c) depicts the features of both erosion and corrosion. From this analysis, it can be said that the concave side surface of the blade at the leading edge suffered from both erosion and corrosion. Erosion causes the grooves to form, and corrosive agents deposit inside the grooves to further weaken the blade at the leading edge, particularly on the concave curvature side surface. Note that in Fig. 2(b), the highlighted failure initiation point is on the concave curvature side surface.

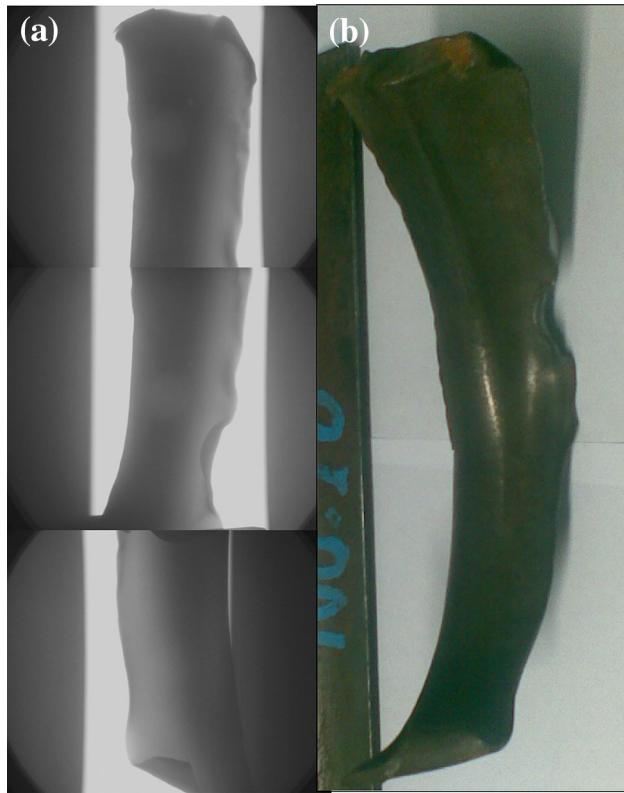
The chemical composition of the blade, analyzed using an OES, is given in Table 1. The composition of the blade matches with that of the manufacturer's standard material composition for X22CrMoV12-1 alloy as per BS EN 10269 [14]. The X-ray radiographic images of the failed blade sample shown in Fig. 3 clearly reveal that there are no internal defects such as pores, voids, microcracks, etc., in

the blade. Hence, the possibility of failure, due to material defects and internal defects like pores, voids, microcracks, etc., is ruled out. It can be noted that radiography technique can detect an internal defect of size up to 10 μm [15, 16]. The measured hardness of the failed blade is found to be in

**Fig. 3** (a) X-ray radiography images of the failed blade, 80 kV x 5 mA (b) photograph of as-received failed blade

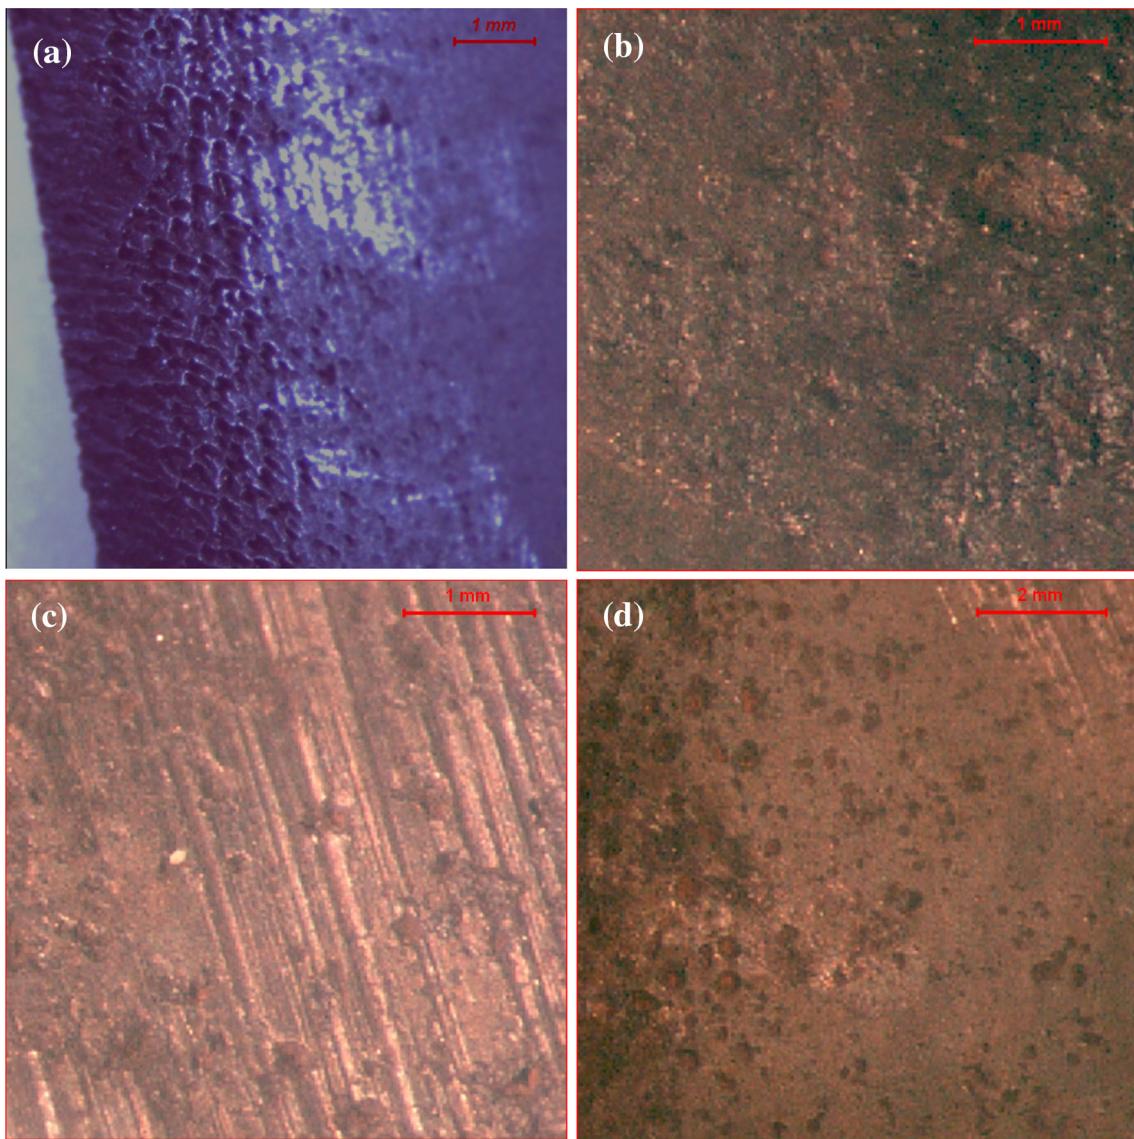
A Stereo micrograph taken along the leading edge of the aerofoil section on the convex curvature of the blade is shown in Fig. 4(a). Severe erosion marks can be seen in this figure. Also, the stereo micrograph taken on the surface of the convex curvature of the blade nearby trailing edge exhibited severe erosion features as shown in Fig. 4(b). Erosion is generally characterized by grooves and patterned wave-like formations on the surface, while pit corrosion is characterized as small holes on the surface with corrosion deposits. No corrosion features were observed on the convex curvature regions of the blade toward the leading edge; however, the regions were

Fig. 4 Stereo micrograph taken on the surface of the blade at (a) along the leading edge, convex side (b) near trailing edge, convex side, (c) on the leading edge concave side and (d) near trailing edge, concave side

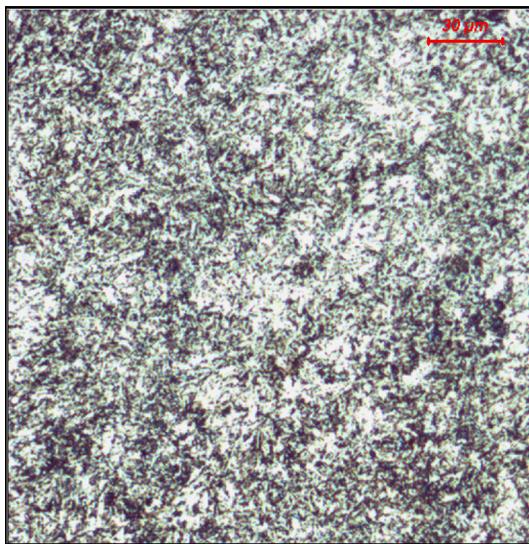
The alloy X22CrMoV12-1 is a variety of high-temperature-resistant steels with 12% Chromium and is employed as manufacturing material for steam turbine blades [18]. At higher temperatures, these materials are highly prone to erosion by flaked-off particles [19] and corrosion-induced fatigue [20]. The microstructure of the blade consisted of tempered martensite, as shown in Fig. 5. This meets the manufacturer's specifications of the material on such applications [21]. However, traces of carbides are seen at higher magnifications (Fig. 6). No degradation in the microstructure of the blade was observed.

Fig. 5 Optical microstructure of the blade at the failed region (tempered martensite)

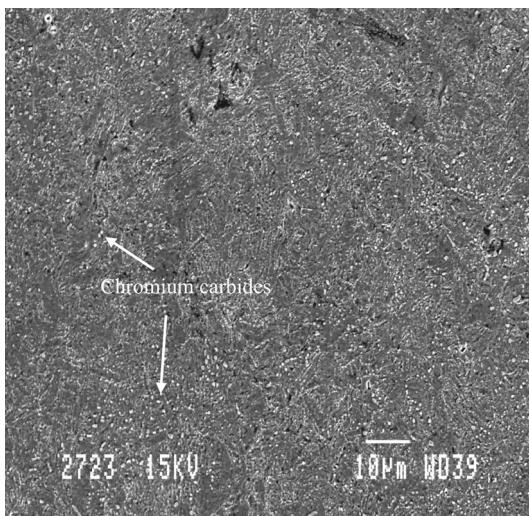
Fig. 6 SEM image of the martensite matrix highlighting the presence of carbide precipitation (white color) with white arrows

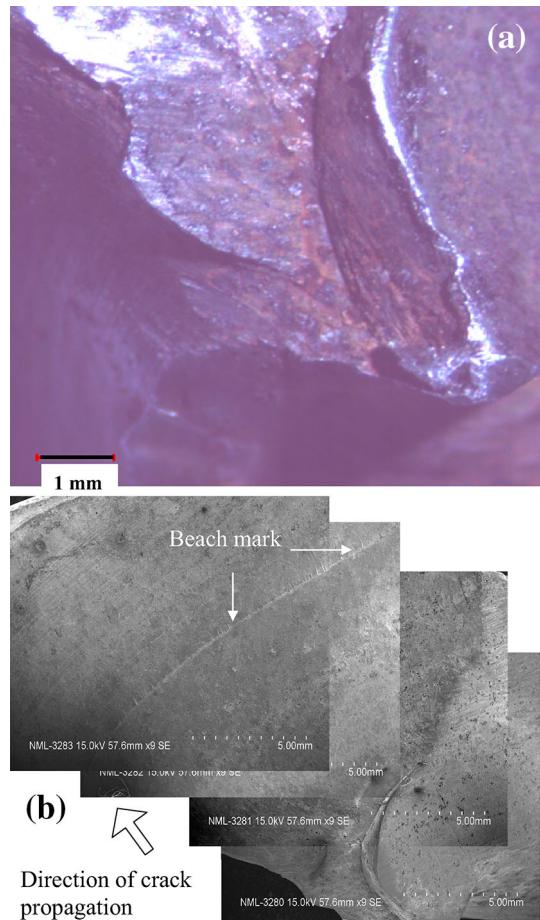
A few scanning electron micrographs of the failed turbine blade taken at the fatigue crack initiation point (see Fig. 2b) are shown in Fig. 7. EDS analysis performed at this region indicates the presence of silicon and chlorine as predominant foreign elements. The scanning electron micrographs arranged in such a way to see along the direction of crack growth, and to reveal the presence of beach marks on the fractured surface which is a typical characteristic feature of a failure due to fatigue [22]. Hence, that the turbine blade undergoing repeated cyclic loadings before the ultimate failure becomes conclusive. Sometimes, the crack initiation point due to corrosion fatigue can be in the aerofoil region of the trailing edge also [7]. However, the location where the corrosive agents accumulate inside the grooves subsequent to the erosion of

Fig. 7 (a) Stereo micrograph of crack initiation point and (b) Sequence of scanning electron micrographs show the crack propagation

accumulation of the deposits containing significant amounts of chloride and silica, it is quite obvious that the mode of failure of the turbine blade is due to corrosion-induced fatigue, which is also referred as corrosion fatigue. The formation of grooves of appreciable size by the erosion

and the presence of corrosive agents such as chlorine followed by severe localized stress concentrations have led to the failure. In the current work, the nature of corrosion is pitting type due to the accumulation of chlorine in the pits formed due to the erosion.

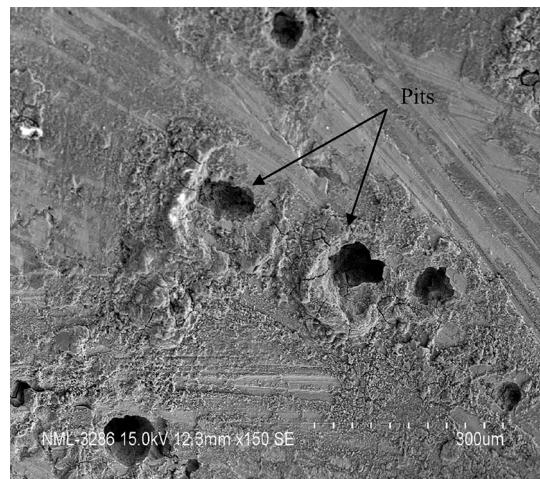
A scanning electron micrograph of the irregular pits on the edge of fractured surface is given Fig. 8. Bulk EDS analysis performed at a pit region reveals surface oxidation and the presence of chlorine, silicon, potassium, and calcium as extraneous elements besides iron as shown in Table 2. The results of the analysis conducted at a location away from the pit are also presented in Table 2. Pitting is commonly associated with chloride deposits along with sodium hydroxide, sulfate, and sulfides [23]. The source of deposits on the turbine blade is the impurities in the water in the form of salts and silica in the boiler water. As steam enters and expands through the turbine, the solubility of contaminants in the steam

decreases and they condense on the surfaces at solution concentrations higher than that of the original contaminant concentration in the steam [4, 24]. Once these contaminants accumulate in the grooves formed by erosion of the surface by silica and water droplets present in the steam, they promote pitting corrosion of the turbine blade.

Fig. 8 Scanning electron micrograph taken on the fractured surface at the crack initiation point showing corrosion pits

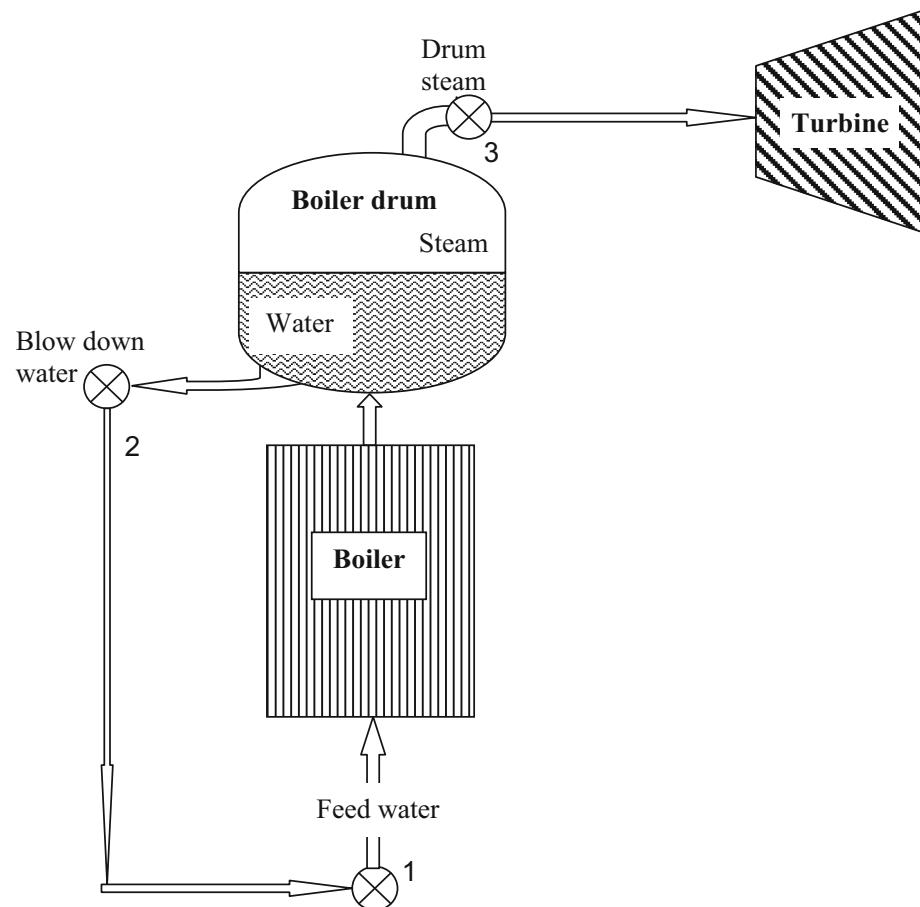
A schematic of the boiler with water flow directions is shown in Fig. 9. The AAS analysis of the water samples collected from three different locations of the boiler namely, boiler blow down, boiler drum steam, and feed water shows the presence of significant amounts of M-alkalinity, chlorine, and silicon (Table 4). It is well known that the presence of chlorine facilitates the localized corrosion attack in the form of pits. Considering the characteristic feature of the failure such as beach marks and pits observed in SEM analysis coupled with the

Fig. 9 Schematic diagram of the boiler and turbine assembly showing the feed water, boiler blow down water, and boiler drum steam locations

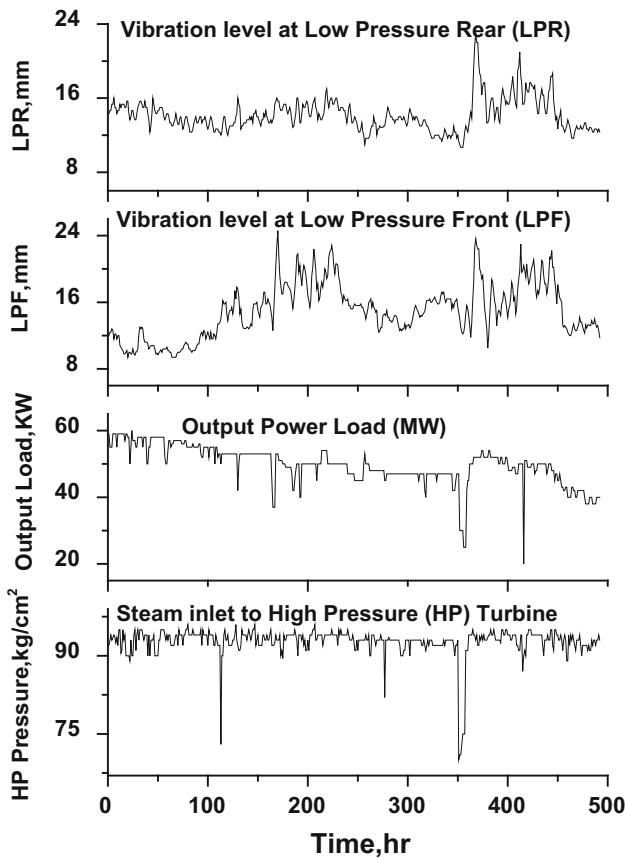
**Fig. 10** Variation in turbine inlet steam pressure (HP inlet), output power load, and vibration levels recorded at the front (LPF) and rear (LPR) of the turbine as a function of time

examined. A sudden substantial drop in the inlet pressure from ~ 95 to ~ 73 kg/cm^2 , followed by sudden reversal to ~ 95 kg/cm^2 at around 113–117 h is observed. In addition, several fluctuations (~ 351 to 357 , ~ 415 h) of varying levels in the inlet pressure could be noticed. The safety limit of inlet pressure of the steam entering into the turbine was defined as ~ 92 kg/cm^2 . However, the average inlet pressure condition is well over ~ 92 kg/cm^2 suggesting that the safe operational limit was deviated during the operation of the turbine. The fluctuations in the output power load and HP inlet pressure measured as a function of time suggest the existence of a reasonable relation between them. Overall, the analysis implies that the failed turbine blade underwent uneven loading conditions due to variation in inlet pressure.

The vibration levels are also indicators of the deviations in the operational conditions. The vibration levels recorded at low-pressure front (LPF) and low-pressure rear (LPR) regions of the LP turbine as a function of time for 492 h are shown in Fig. 10. Also given are the HP inlet steam pressure and output load of the turbine. For the disturbance in HP inlet steam pressure at 113–117 h, vibrations in LPF can be observed with no such vibrations at LPR. However, as the time progressed, both LPF and LPR showed similar vibrations. This could be due to the onset of the failure of the blade. Note that the average levels of vibrations in LPF and LPR are increased with the time. The onset of failure can amplify the vibrations and the blades further undergo heavy loading. However, such phenomena are not seen in the case but the change in the vibration is observed in response to changes in HP inlet pressure only. It is an evidence of the occurrence of frequent overloading due to the changes in HP inlet steam. The sudden loading and unloading phenomenon on the blade, together with the constant operation of the turbine in overloaded condition and vibration fluctuations, is considered to be critical in culminating the failure.
