Analysis of failures encountered during rolling of rings of maraging steel

M. Nageswara Rao¹, K. Sivasubramanian²,
M. Chatterjee²

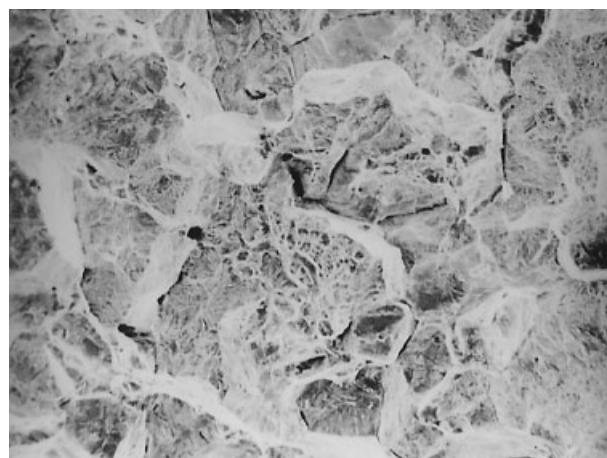
Microstructural examination of the rolled rings revealed a somewhat elongated grain structure elongation being in the tangential/circumferential direction. There was no evidence of recrystallisation and PAG boundaries were found decorated with carbonitride particles. Figure 1 gives the scanning electron micrograph of fracture surface of the material. It is a predominantly intergranular failure. Secondary cracks running along grain boundaries can also be seen.

Fig. 1. Scanning electron fractograph of a broken test specimen with a relatively low fracture toughness (75–80 MPa \sqrt{m}) (Magnification x150)

Failures to realize the required K_{Ic} in the campaigns A&B were related to grain boundary precipitation of carbonitrides. The grains were elongated in the circumferential / tangential direction and the 820 °C treatment was not effective in causing recrystallisation of the elongated grain structure. The PAG boundaries aligned in the tangential direction and decorated with carbonitride particles thus provided easy crack propagation paths when K_{Ic} was tested in the tangential direction. The rings after hot-rolling were allowed to cool through the embrittlement range (980–820°C) and the well studied phenomenon of thermal embrittlement in maraging steel leads to preferential precipitation of carbonitride particles at the PAG boundaries. Poor K_{Ic} values in the tangential direction were the consequence.

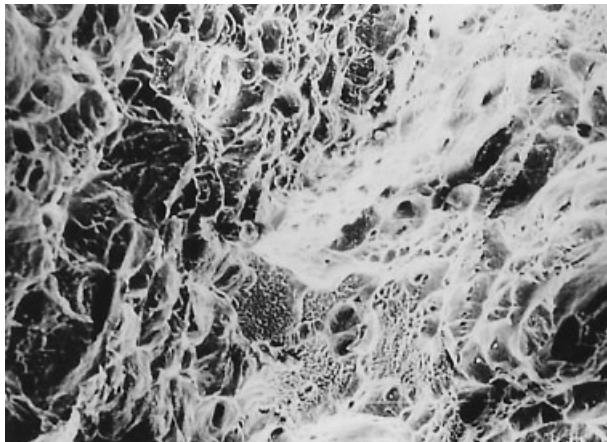
Fig. 3. Scanning electron fractograph of a broken test specimen with a relatively high fracture toughness (95–102 MPa \sqrt{m}) (Magnification x150)

With failure in campaign C, the pre-heating temperatures for the stock were revised upward to 1200/1250 °C for the next campaign (D). This lead to satisfactory completion of the ring rolling operations in that the aimed final dimensions of the rings were realized with acceptable levels of distortion / ovality. However consistently high fracture toughness values could be obtained only after resorting to a two- or three-stage solution treatment following the hot working operation [1]. Figure 3 shows the scanning electron micrograph of fracture surface of broken test specimen cut from test ring drawn from X type ring after three stage solution treatment. It can be seen that the fracture is transcrystalline. The fracture toughness values were in the range 95–102 MPa \sqrt{m} .
